## **Atlantic Division, Naval Facilities Engineering Command**

### **ACCIDENT ABSTRACT**

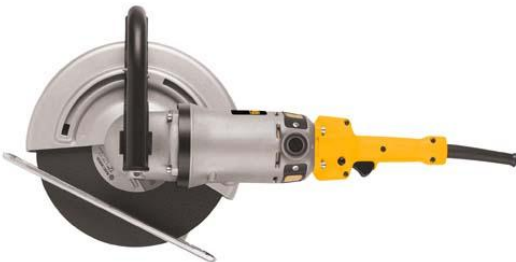
**Portable masonry chop saw**

A mason was attempting to cut an 8" X 16" hollow web concrete masonry unit (CMU) with a portable electric saw known as a chop saw. Apparently the saw kicked back when making an unusual cross cut causing lacerations to the employee thigh and wrist. The employee received approximately 100 stitches.

Apparently the employee was not able to control the saw when the kickback occurred.

1. The saw being used is typically used to create penetrations in existing walls. The more appropriate saw for cutting CMU to be installed when cross or long rip cuts are needed for notching CMU into and around objects, is a masonry table type saw.
2. Manufacturers' specifications list portable electric chop saws of this type with a weight of approximately 30 – 35 lbs. If used for prolonged periods the saw may cause the operator tire and loose the tight grip necessary to control the saw.
3. The design of the saw guard requires the saw blade to be fully inserted into the material being cut. If not fully engaged rotating parts of the saw blade are exposed to the worker.
